## **SERIOUS INJURY ACCIDENT: January 2013 Contractor Employee Struck By Falling Material**

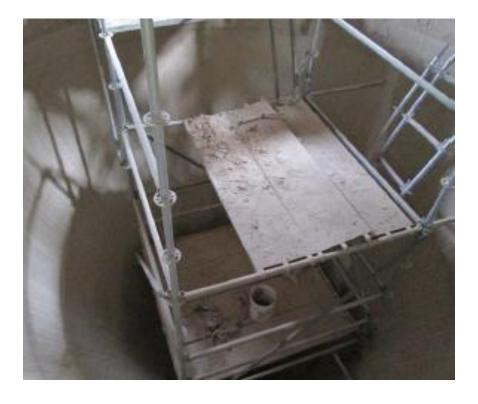
On January 8, 2013, a contractor worker was seriously injured when he was struck in the head by a piece of material build-up that fell from the ceiling of the Pre-Heater Tower where he was working. The injured worker was part of a crew erecting scaffolding inside the Pre-Heater Tower. As he was lowering scaffolding material to co-workers, he was struck in the head by falling material, which rendered him temporarily unconscious, and knocked him off the platform on which he was working. His fall protection harness and lanyard stopped his fall. His co-workers released him from the harness and kept him immobile until rescue workers arrived. EMS personnel transported him to a local hospital where he was treated for a mild concussion and bruising along his neck and upper back. He was released from the hospital in the afternoon of the next day.

Platform where miner was injured

- The accident occurred as a result of the failure to identify and eliminate workplace hazards prior to workers beginning work.
- Virginia mineral mining laws and regulations require workplace examinations by a certified mine foreman or cement plant examiner prior to workers beginning work. Uncertified personnel examined the work area, but failed to recognize the fall of material hazards that existed.

- Hazard training provided to the contractor employees was inadequate as no reference was made to the potential hazard from material buildup inside the vessel. Specific hazards of the area to be worked in should be a part of any Site Specific Hazard Training.

- Conducting proper workplace examinations should be reviewed with all employees along with hazard recognition.
- The accident, and all factors that led to its occurrence, should be reviewed with all employees.
